# WOODCLIFF LAKE DAM

## PHASE I INSPECTION REPORT NATIONAL DAM SAFETY PROGRAM

NJ00247

JUNE 1978

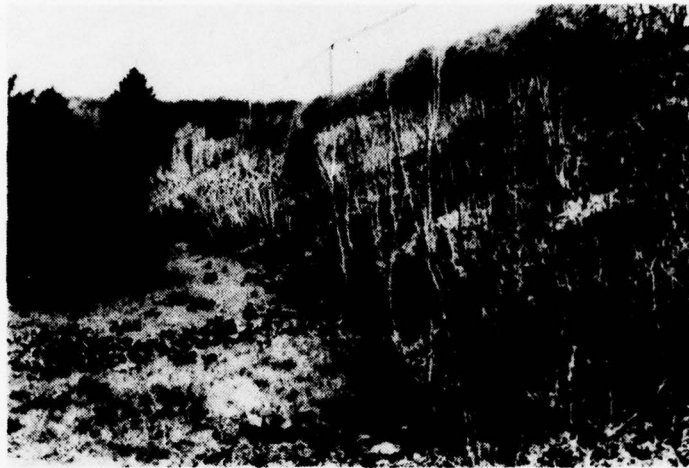
The embankment slopes are two on one and there are no signs of past or present downstream slope instability. Upstream slopes are protected by riprap and no problems were apparent above the water line. Downstream slopes were overgrown with brush and small trees. Several holes dug by burrowing animals were observed.

Photo 5 - View of downstream face of embankment standing in left abutment area looking toward right abutment

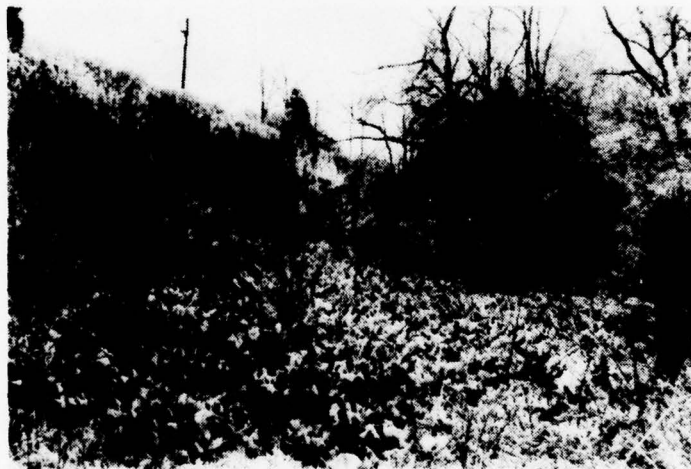
Photo 6 - View of downstream face of embankment standing in left abutment area looking toward left abutment; note large areas of skunk cabbage growth at toe of embankment indicating high water table

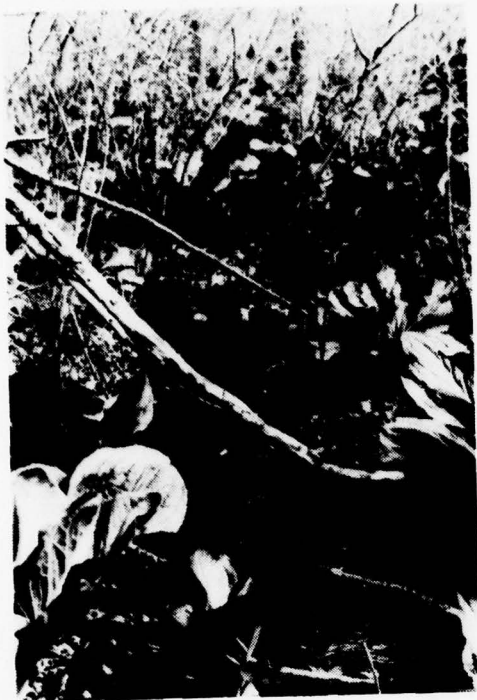
Seepage was observed in four locations just downstream of the embankment toe near the left abutment. The seepage combines to form a 2-foot wide rivulet carrying 5 to 10 gpm of clear water. At the time of the inspection, vegetation in the area left of the gate control house was indigenous to swampy areas. One observation well was located at the toe of the downstream embankment approximately 75 feet left of the gate control house. The level of water in the well was 1 ft. below ground surface.

Seepage in this area is thought to be significant. Seepage may be occurring through cracks or joints in the corewall or through or under the sheet piling.

Photo 7 - Detail of seepage area  
on left abutment-rivulet  
downstream of embankment  
toe

3. Burrowing animals should be destroyed and their holes backfilled as best as possible, wherever they exist in the downstream embankment or at the area below the toe line.
4. Piezometers or observation wells should be installed in the embankment near the left abutment to determine the paths of the seepage observed. Seepage may be occurring through cracks or joints in the corewall or through or under the sheet piling. Once the location of the phreatic surface in the embankment is determined, then effective corrective measures can be considered and undertaken. Piezometers should also be installed in the vicinity of the gate house where there are no signs of leakage to provide a comparison with an apparently satisfactory section.

7. While the pond to the north of the left abutment did not appear to be a threat to the safety of the reservoir at the time of the inspection, periodic inspections of the area are recommended, to verify that the situation with respect to seepage is stable.

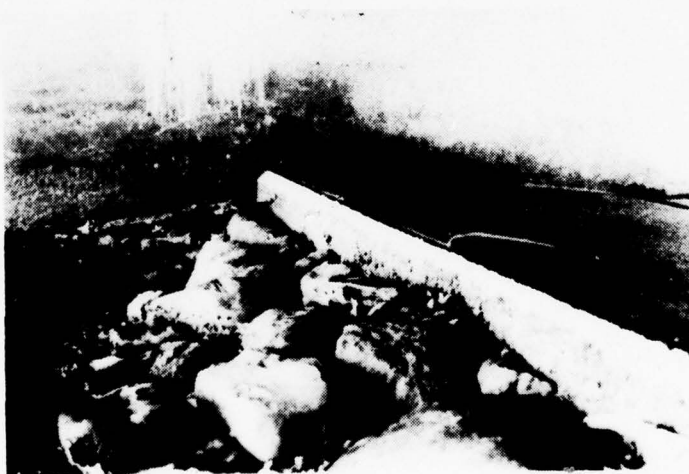
Photo 10 - Upstream face of spillway weir under spillway bridge showing approach stone protection, and abandoned and bent flashboard pins

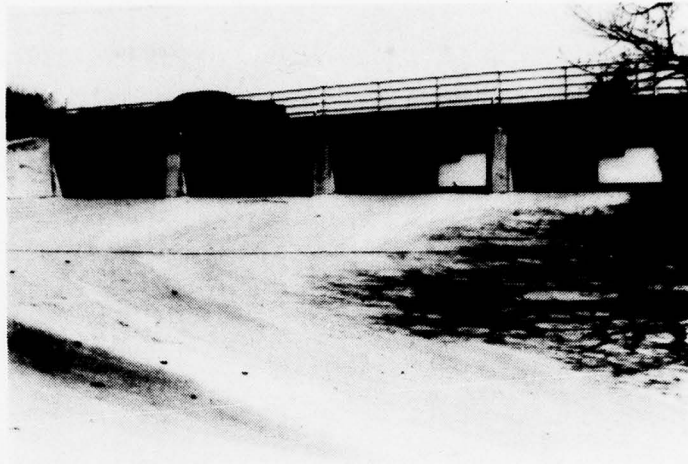
Photo 11 - View of spillway chute channel looking upstream at spillway bridge and Church Road; spillway chute turns through an angle of approximately 60 degrees at upper end

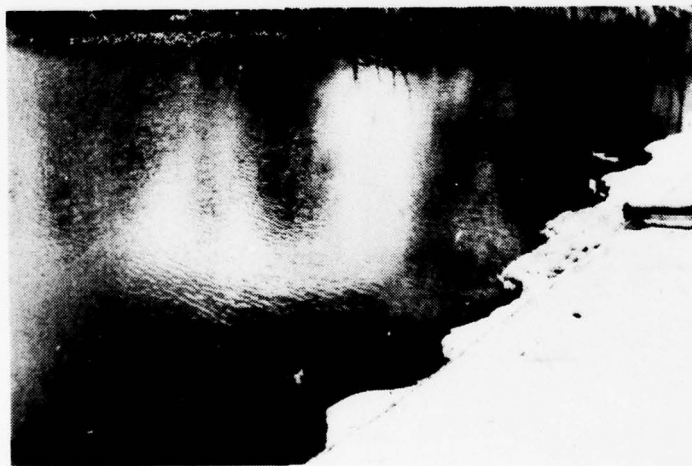
the right stilling basin wall was heightened by 2.5 feet in the area where the chute turns through an angle of approximately 60 degrees, to prevent overtopping caused by supercritical flow standing waves. On November 8, 1977, during a severe rainstorm, the increased water velocity attained in the spillway chute by the smoother repaving caused considerable local damage on both sides of the channel downstream of the chute walls removing bank areas approximately 30-ft. wide by 100-ft. long, and redeposited the coarser fractions 75 ft. to 100 ft. downstream in the channel. The increased velocity also tore away the top edge of the steel sheet piling from the end of the chute slab concrete and bent it downstream.

Photo 14 - Detail of damage to steel sheet pile cut-off installed at end of spillway chute channel caused during storm of November 8, 1977. Sheet piling has been torn away from end of chute slab and bent downstream

- (1) The erosion at the end of the spillway chute and in the downstream channel should be repaired and protected from future erosion. The downstream sheet pile cut-off should be repaired and an energy dissipation sill installed.
- (2) The downstream embankment should be cleared of trees and brush and a suitable vegetative cover established.
- (3) Burrowing animals should be destroyed and their holes backfilled.
- (4) The water level recorder in the gaging station should be repaired.
- (5) The owner should upgrade his Operation and Maintenance procedures by issuing an Operation and Maintenance Manual.
